**N°0077022-S****Performance Test Report****Product:** SOFORD PPSD

**Subject of Request:** Performance Test Report**Specifications:** FORD – STD N° ES-XU5T-14A099-AA

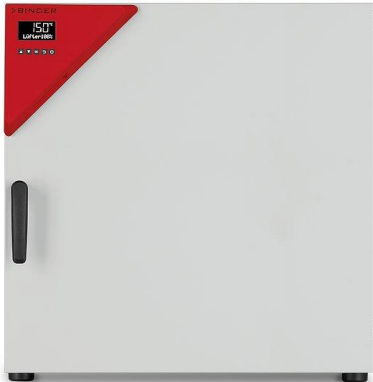
<u>Test condition :</u> <ul style="list-style-type: none"> <li>- Aging 30 samples of 380mm in air oven for 3000H at 100±3°C</li> <li>- Check the behaviour of 5 samples at 500, 1000, 1500, 2000, 2500 and 3000 hours.</li> <li>- Wrap the tubing around a mandrel (diameter = 4X the inside diameter tubing)</li> <li>- Rotate the tubing at 1 turn per 10 seconds</li> </ul>

<u>Requirement :</u>  No tubing crack or deformation.

Equipment - Hot Chamber - AGIN026

Time	500h	1000h	1500h	2000h	2500h	3000h
Result	No crack	No crack	No crack	No crack	No crack	No crack

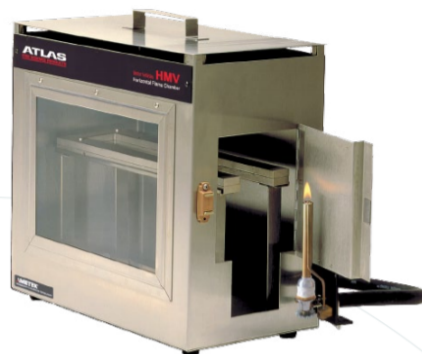
This test has been done according to ISO 3795 / SAE J369 specification for horizontal flammability.

- This test was performed on 5 samples of 300mm length.

Burning speed 100 mm/min (max

Equipment - PERF289

1	2	3	4	5	AVERAGE
Burn Time (sec.)	235	227	212	220	221	-
Burn Length (mm)	200	200	200	200	200	-
Speed (mm/min.)	51	53	57	55	54	<b>54</b>

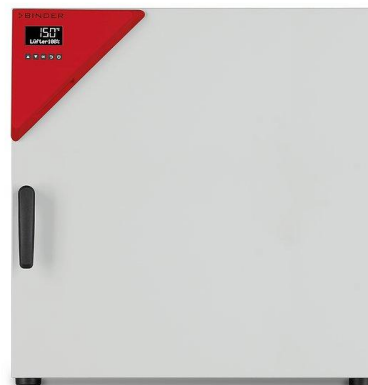
- Tubes: 380mm
- Spray the test specimen until the tube surface is thoroughly soaked
- Remove and allow it to drain vertically for 20 minutes
- Bend the specimen about a 40mm diameter mandrel
- Maintain the specimen bent about the mandrel and inspect after 24H, 48H and 72H

No tubing crack or deformation.

Equipment - Hot Chamber

Test fluid		Temp	Pass or Fail
Name	Reference fluid		
ENGINE COOLANT	ASTM D471, service fluid 104	90±3°C	Pass
BRAKE FLUID	SAE RM-66-04	23±5°C	Pass
GASOLINE	ISO 1817, Liquid C	23±5°C	Pass
DIESEL FUEL	ASTM D471, Ref fuel F	23±5°C	Pass
METHANOL	ASTM D471, Ref fuel K	23±5°C	Pass
TRANSMISSION FLUID	CITGO #33123	90±3°C	Pass
POWER STEERING FLUID	ASTM D471, IRM 903	90±3°C	Pass
ENGINE OIL	ASTM D471, IRM 902	90±3°C	Pass
ENGINE CLEANER	Gunk	23±5°C	Pass
BATTERY ACID	H2SO4 (s.g. 1.260 +/-0.005)	23±5°C	Pass
WINDSHIELD WASHER FLUID	C9AZ-19550-A	23±5°C	Pass
