TEST REPORT	Project no.	Requisition no.	Report no.
	162348 / (IDDO-002304 - V710 wire plug)	DVZ22-162348-715	DRAFT
		Rev. / date	Rev. / date
		0. / 11.10.2022

Name	Cavity plug: FPN-6U5T-10C930-GA
Part number(s):	7158-9221-00

Test seq.	Test name	Test status	Result	Page
	Test specifications & applicable documents			3
	Test samples			3
	Equipment list			4
	5.4.6 – Vibration/Mechanical Shock	Completed	O	5
	5.4.9 – Cavity Damage Susceptibility	Completed	X	12
	5.4.10 – Terminal/Cavity Polarization Test	Completed	O	16
	5.4.13 – Connector Seal Retention – Unmated connector	Completed	O	19
	5.4.14 – Connector Seal Retention – Mated connector	Completed	O	20
	5.6.5- Submersion	Completed	O	21
	5.6.6 – Pressure/Vacuum Leak	Completed	O	23
	5.6.7 – High Pressure Spray	Completed	O	27
	5.9.7- Sealed Connector System Environmental Test Sequence - TUAB	In progress		28
	Revision sheet			31

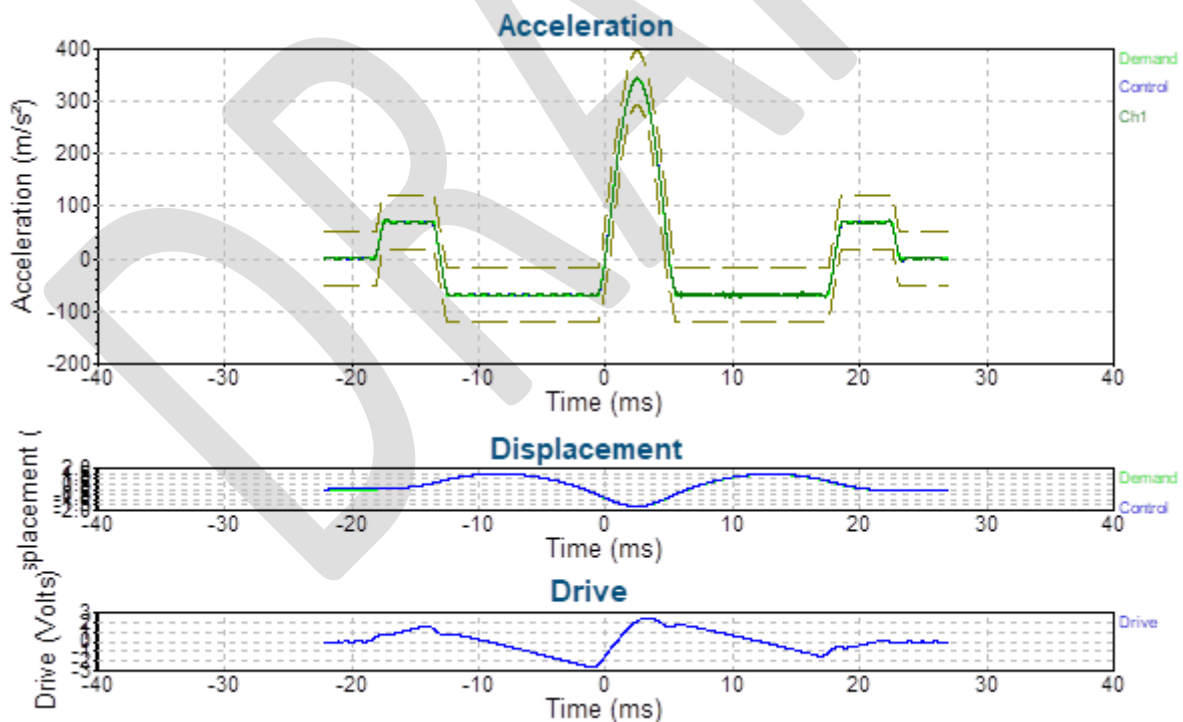
Figure 2

Vibration Class	Shocks per Axis	Wave Shape	Direction (\pm)	Duration (ms)	Acceleration (g)
V2	10	Half Sine Wave	Positive	5 to 10	35

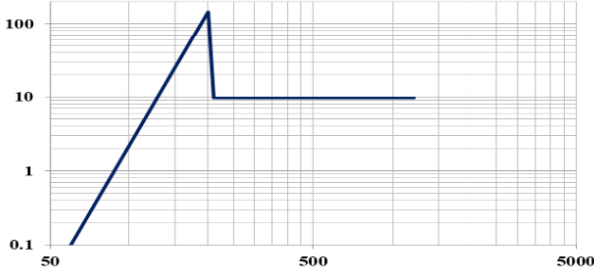
Level	Random			Sine
	F (Hz)	PSD (m/s ²) ² /Hz	PSD g ² /Hz	
V2	60.0	0.096	0.00100	Vibration schedule at this level does not have a sine component
	200.0	144	1.50000	
	210.0	9.60	0.10000	
	1200.0	9.60	0.10000	
	g (rms)	119	12.1 g

Level	Random (PSD in (m/s ²) ² /Hz versus Frequency in Hz)	Sine (Acceleration in m/s ² versus Frequency in Hz)
V2

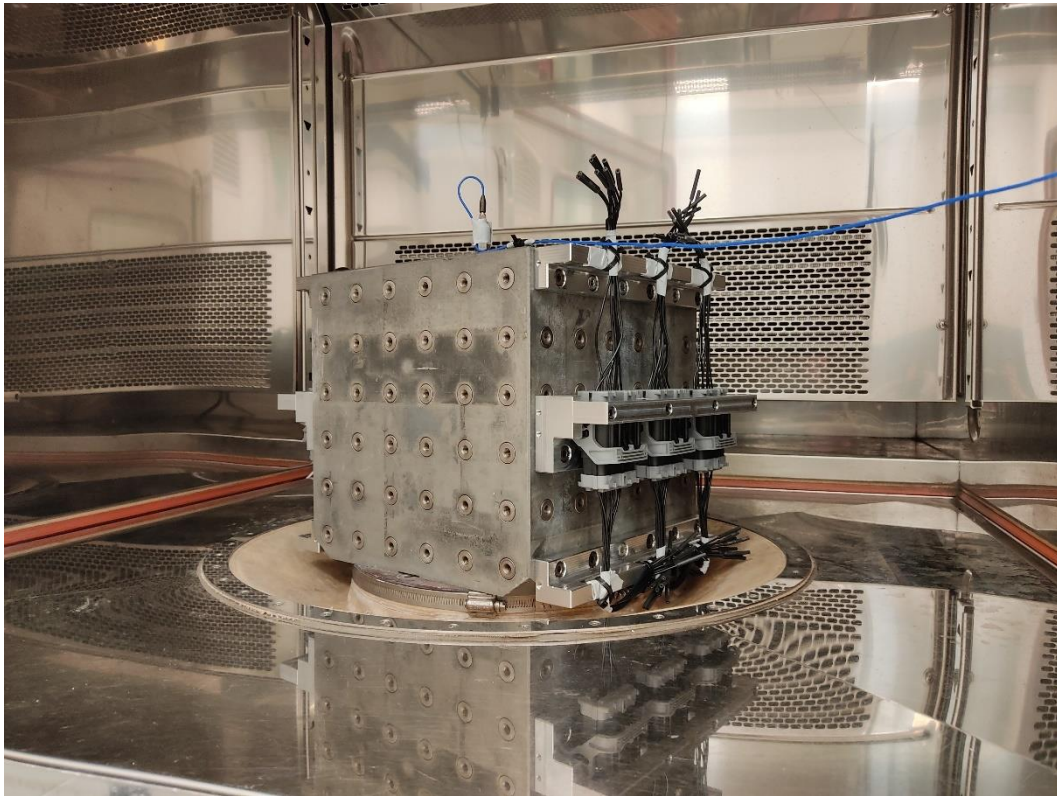
Figure 3 – X axis

Test setup:

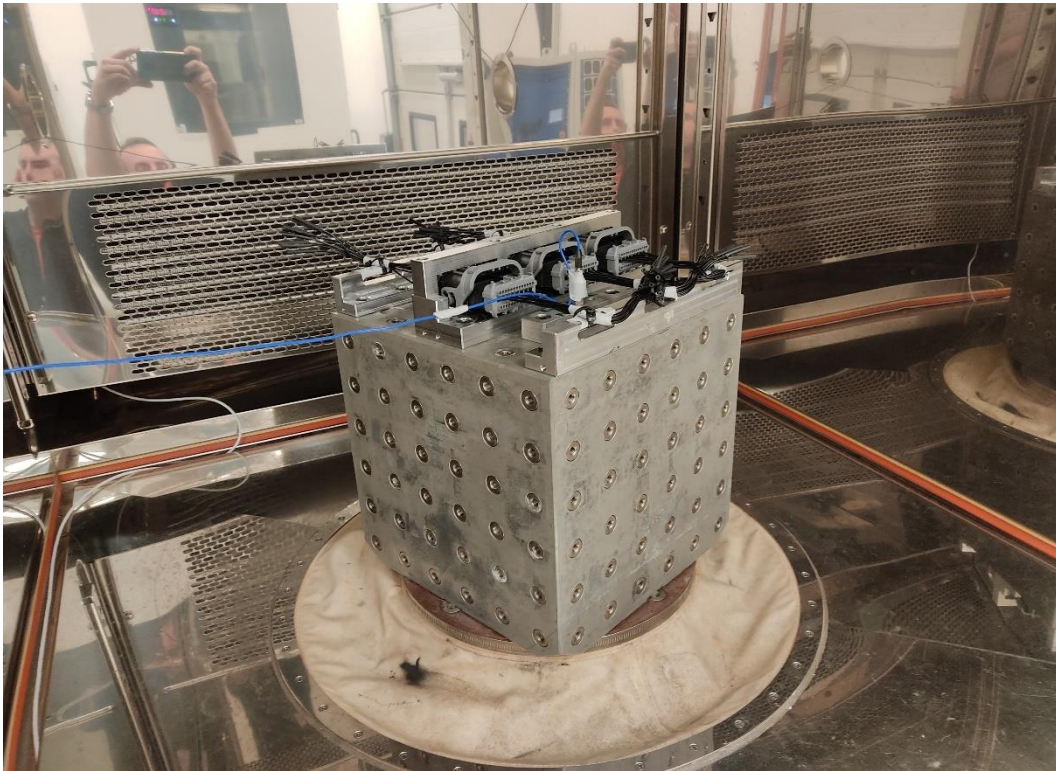
Figure 5– Z axis

Test setup:

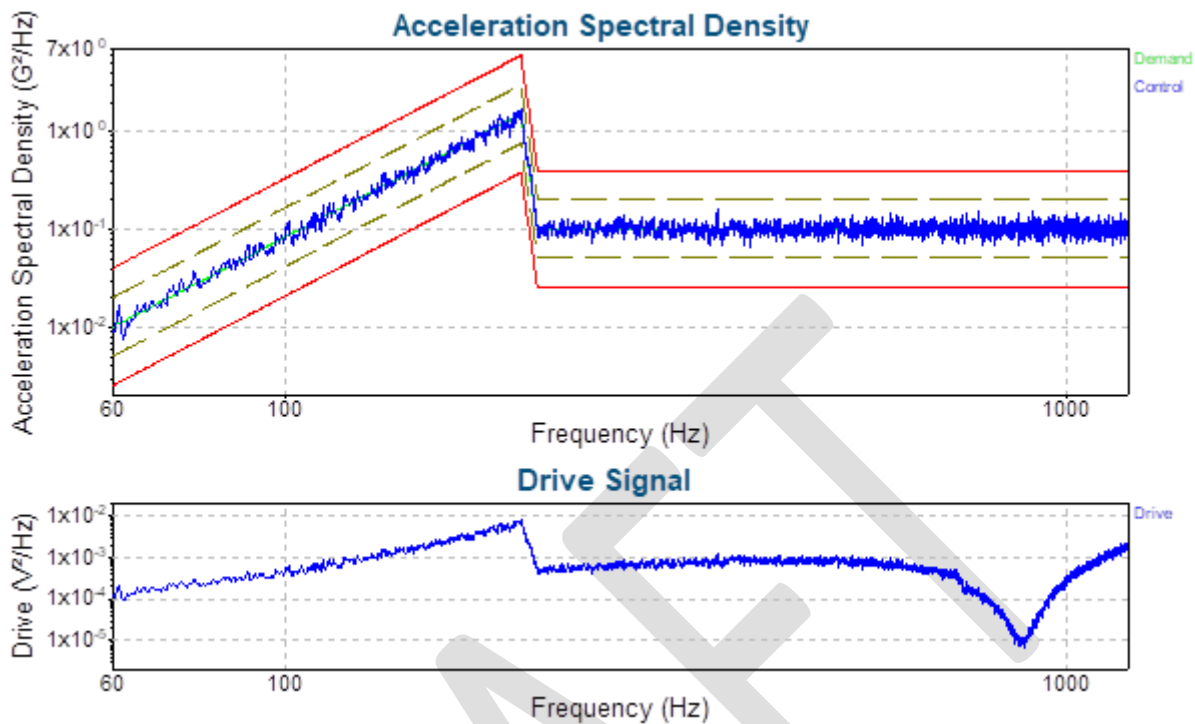
Figure 6 - X axis

Test results:

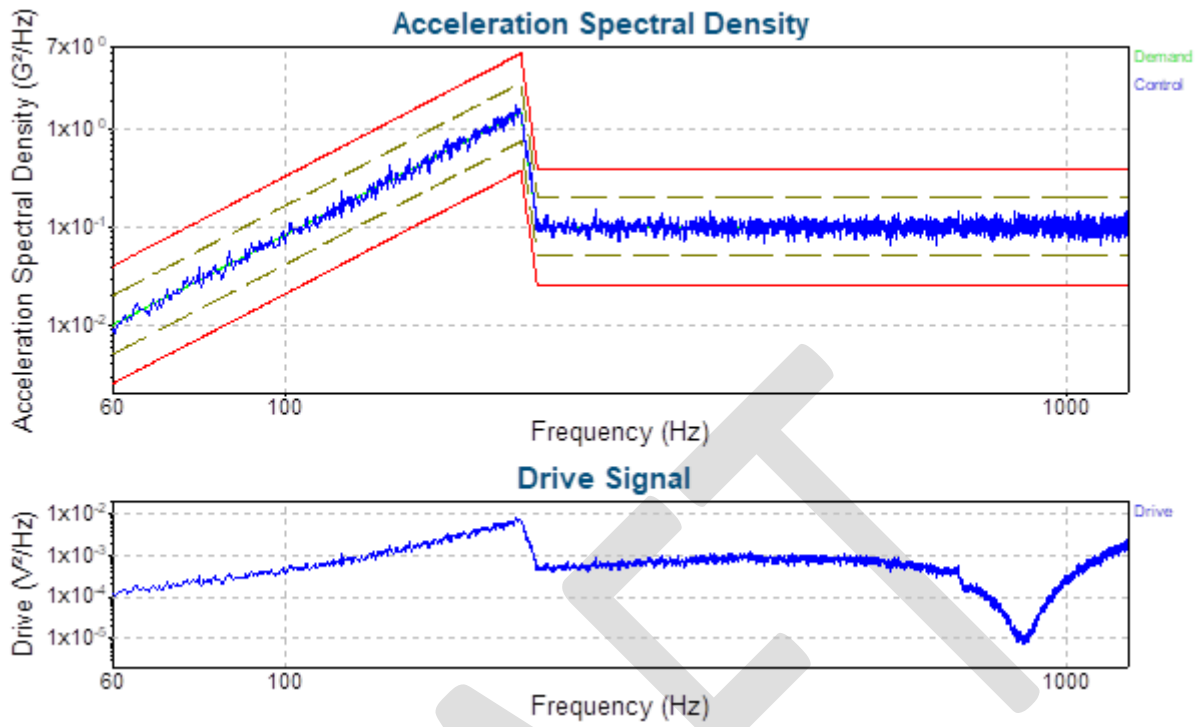
Figure 8 - Z axis

Test results:

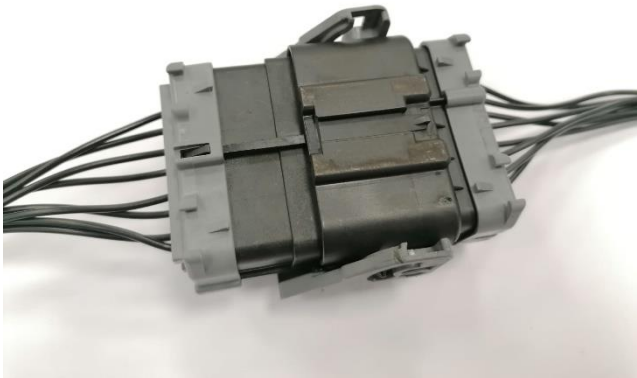
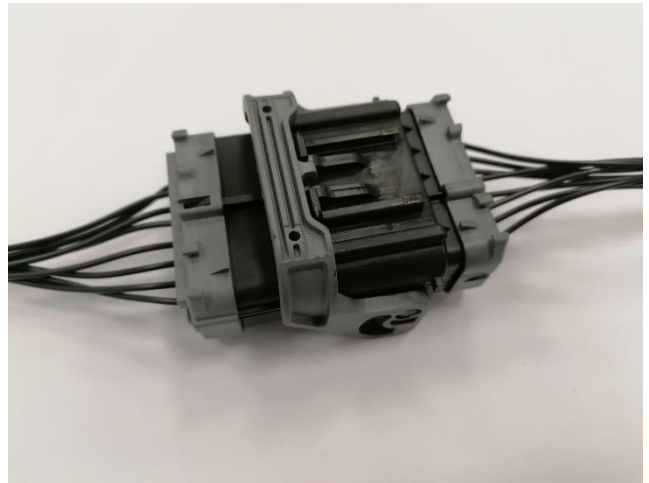
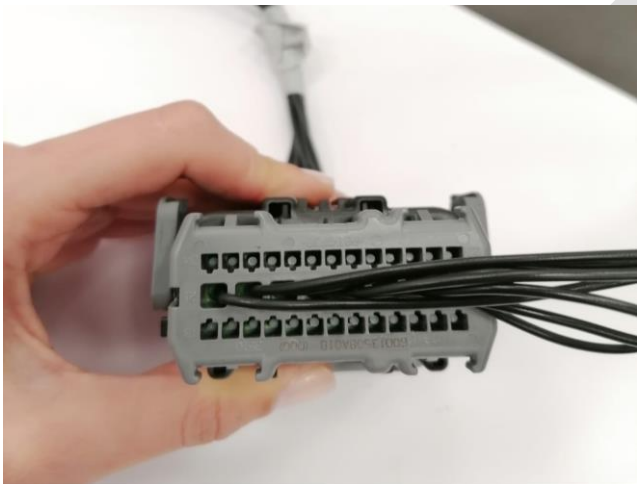
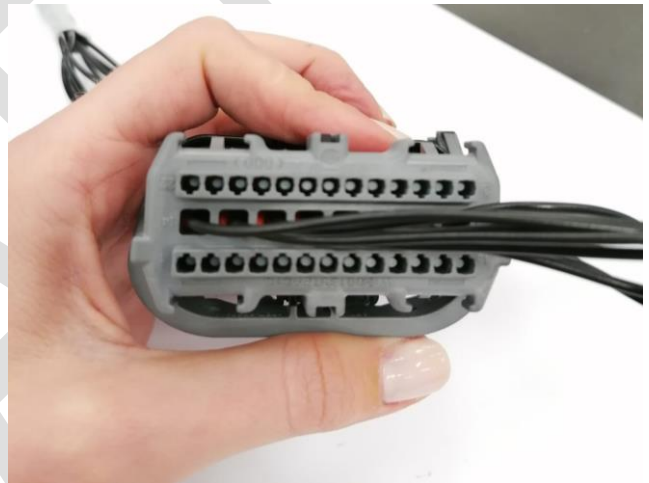
No deterioration on any of samples. No fall out cavity blind plugs on any of the samples.

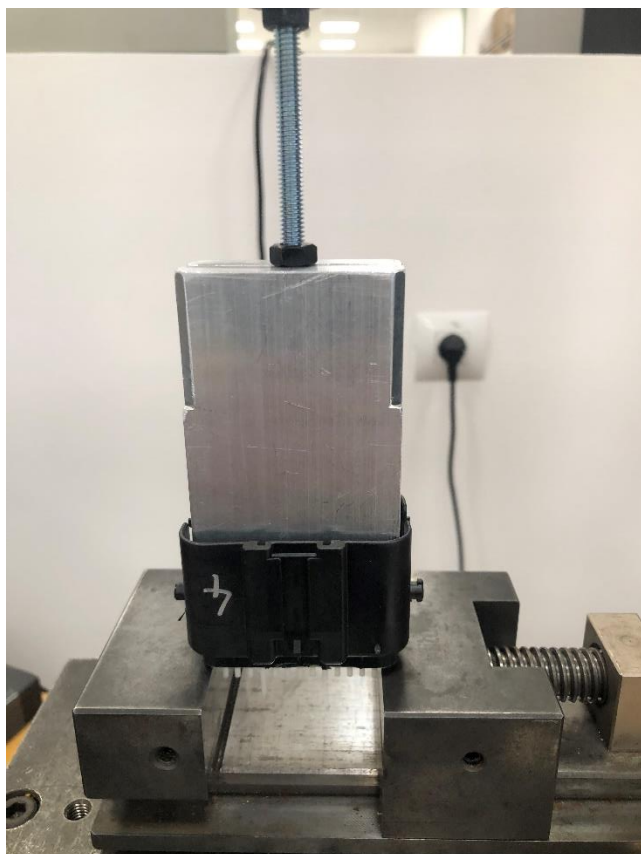
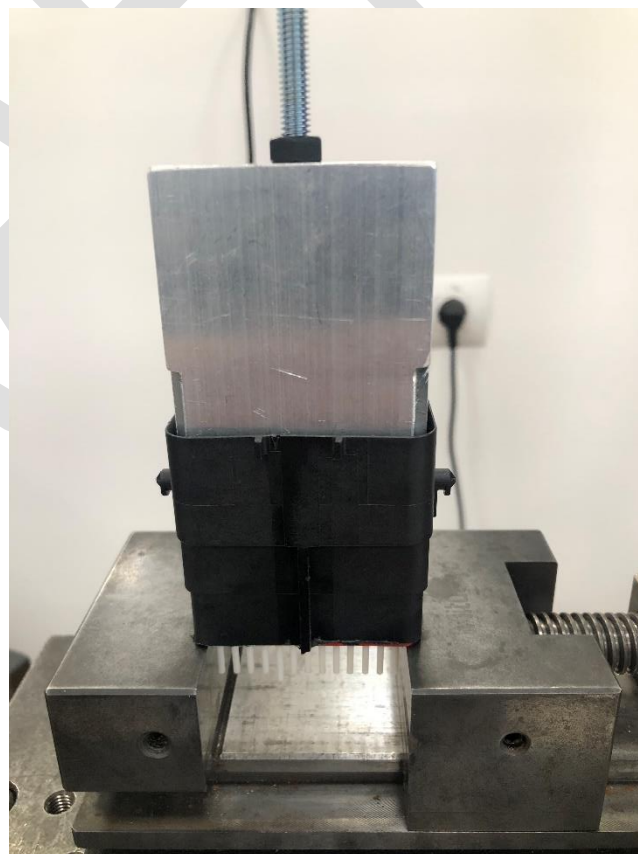
Test setup:

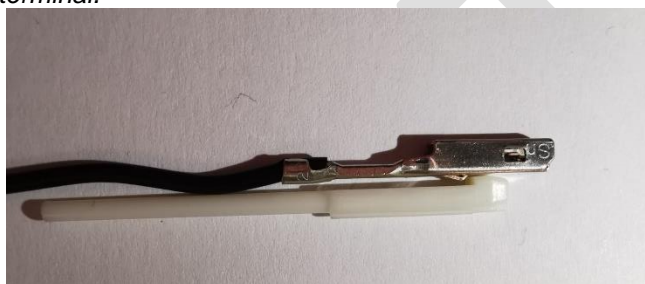
*Insertion depth of cavity plug not same as terminal cavity plug lance locks before terminal lance.

*Cavity plug is shorter than terminal.

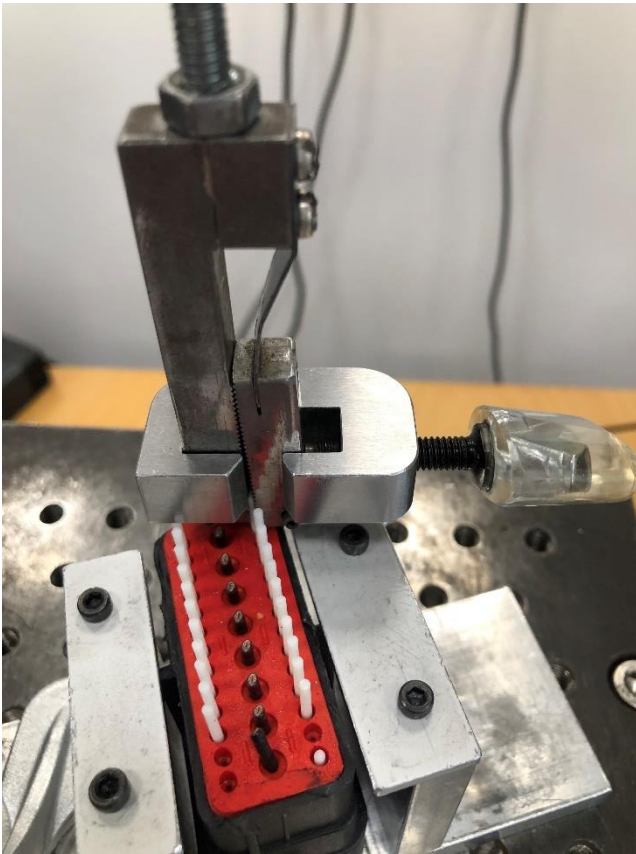
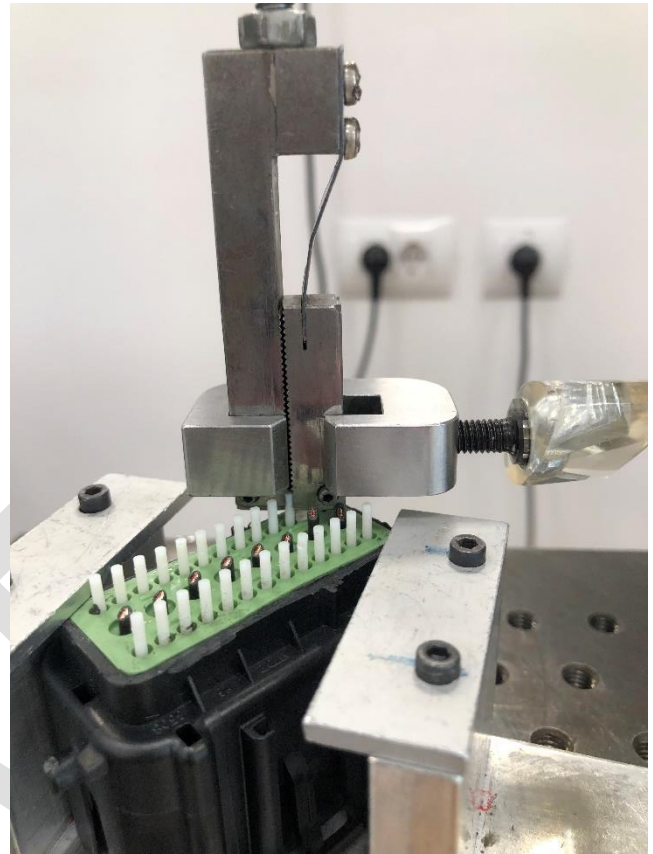
Test setup:

Female			
Sample	Force [N]	Requirement	Results
1	96	> 50 N	O
2	84		O
3	87		O
4	87		O
5	91		O

Male			
Sample	Force [N]	Requirement	Results
1	127	> 50 N	O
2	132		O
3	118		O
4	139		O
5	137		O

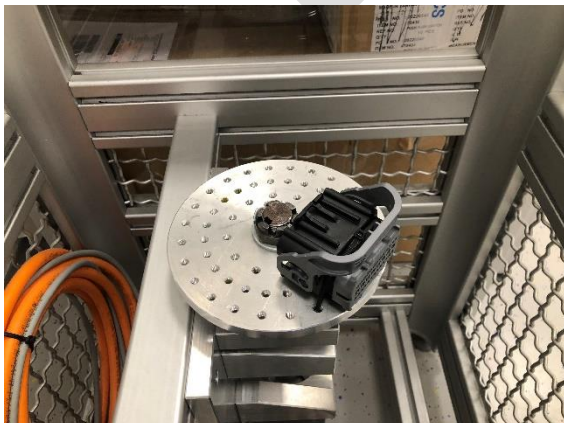
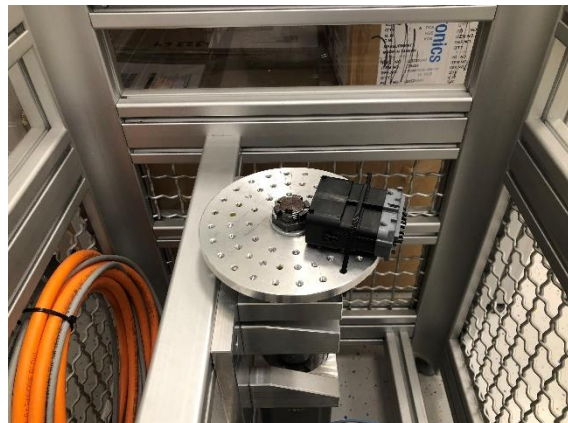
Rotate the table at a speed [rpm] to generate a minimum acceleration of 1960 m/s^2 [$\approx 200g$] for a minimum of 10 seconds. Direction is optional. Equation below is for calculate the required RPM.

In both case the connector seal retained in design position.

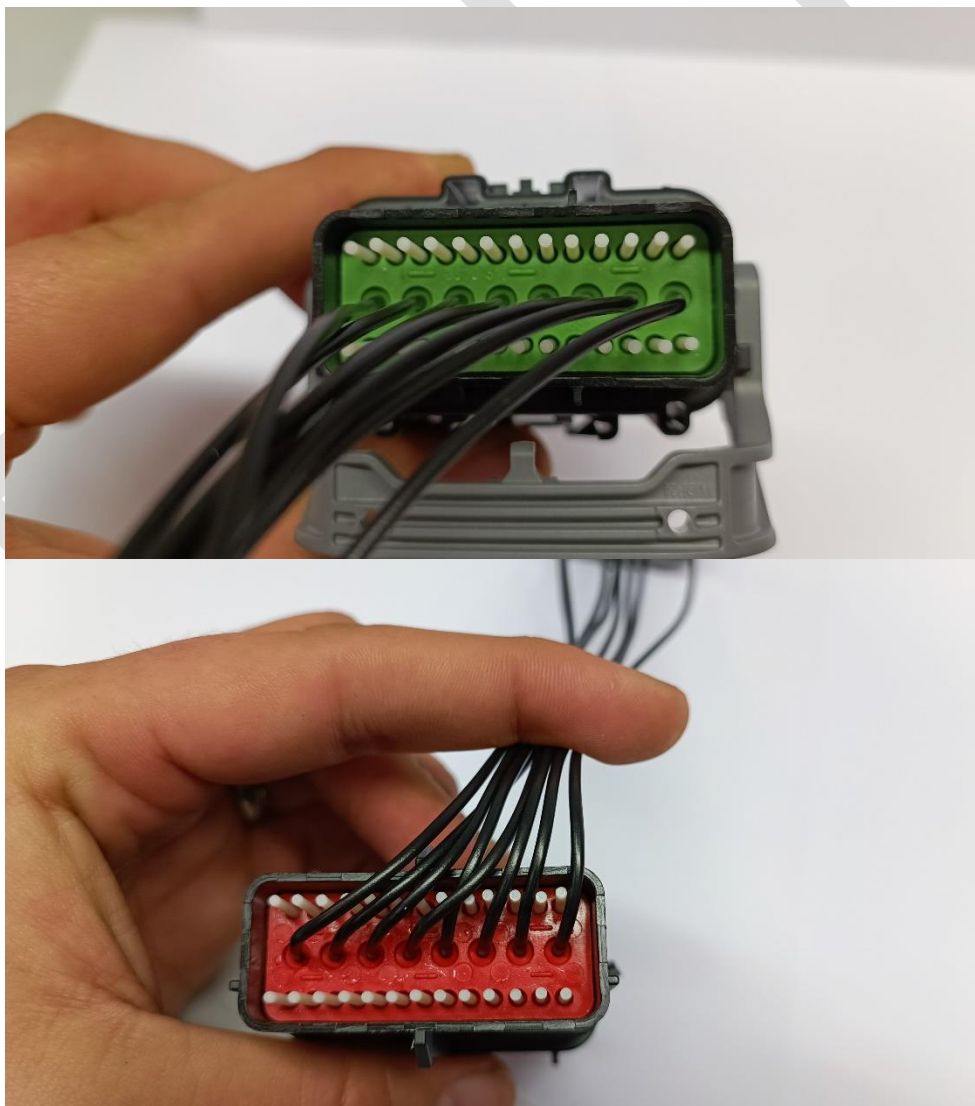
Figure 17

Seal remains on the connector and in its intended position

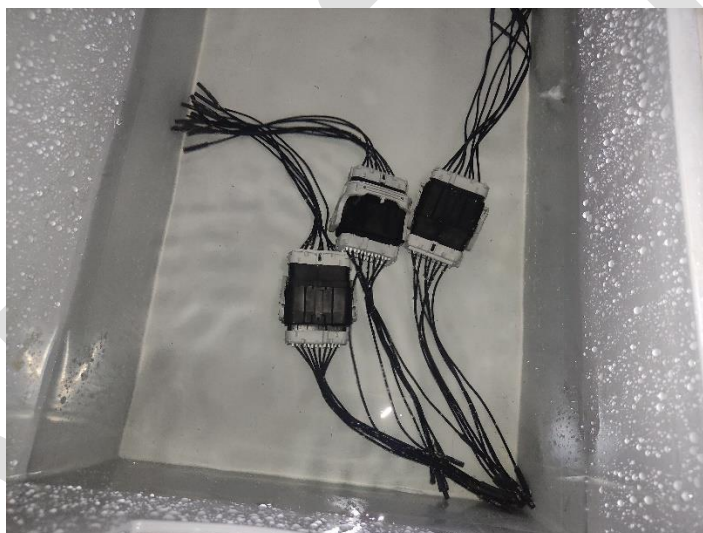
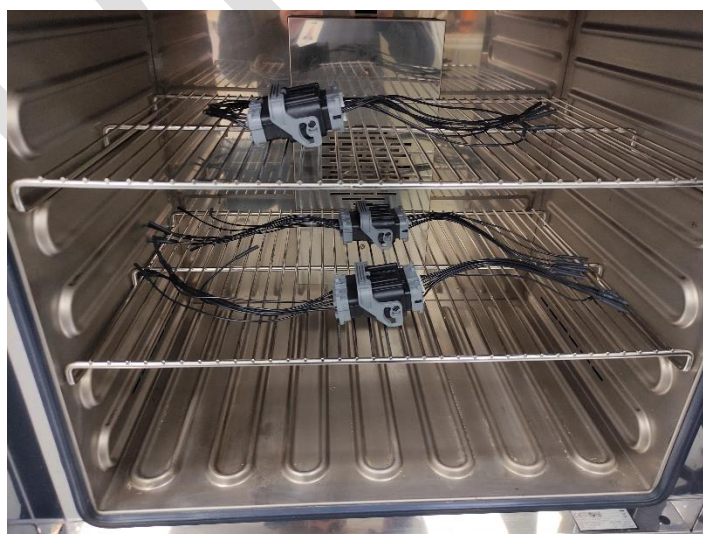
Figure 18

Temp.: 0°C/30min. (salt water solution)

150°C/120min. (chamber)

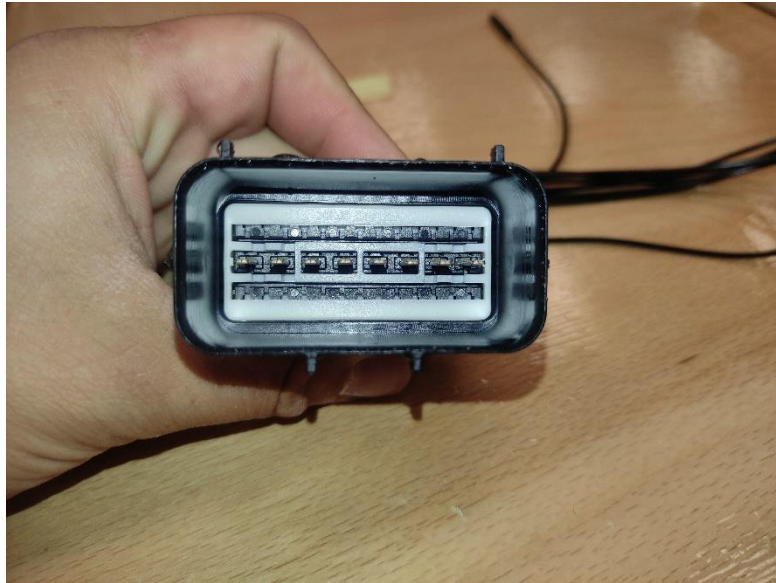
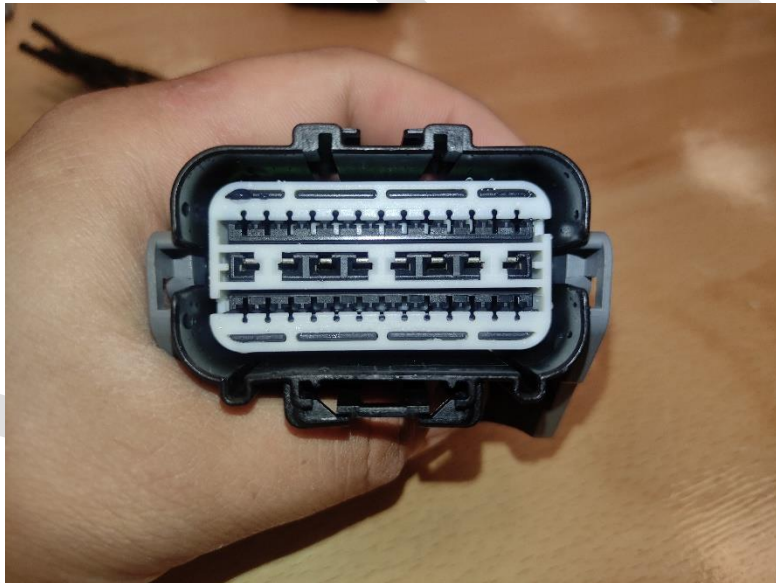
Figure 19

No water ingress of any sample.

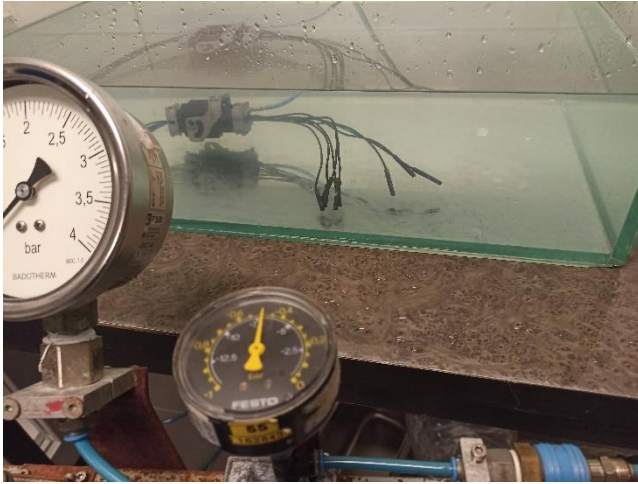
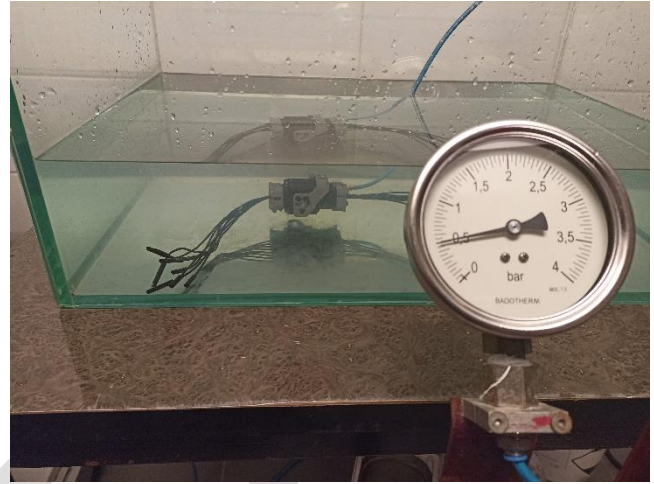
Figure 21

- 48kPa/15 sec

No bubbles visible.

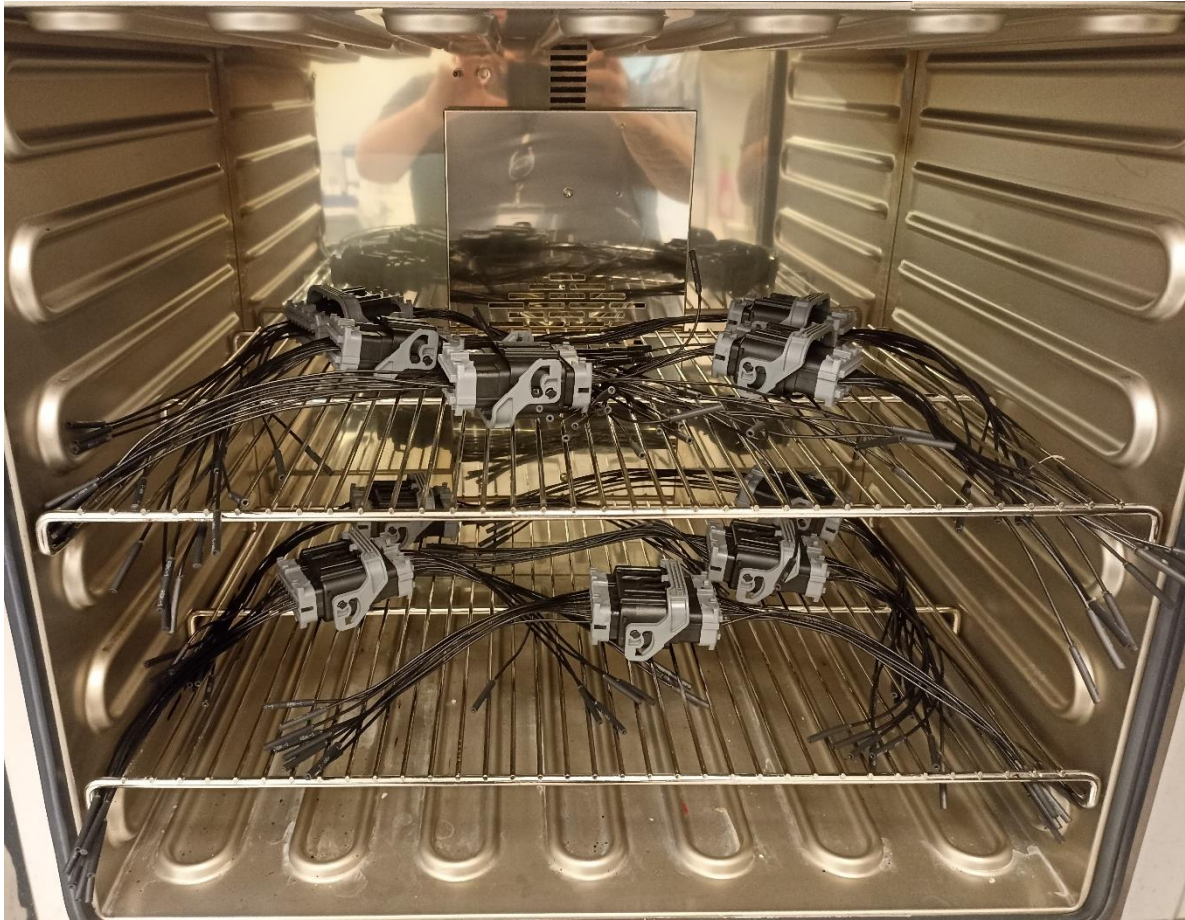
Figure 23

- Heat soak all samples for 70 hours at the maximum temperature 125 °C

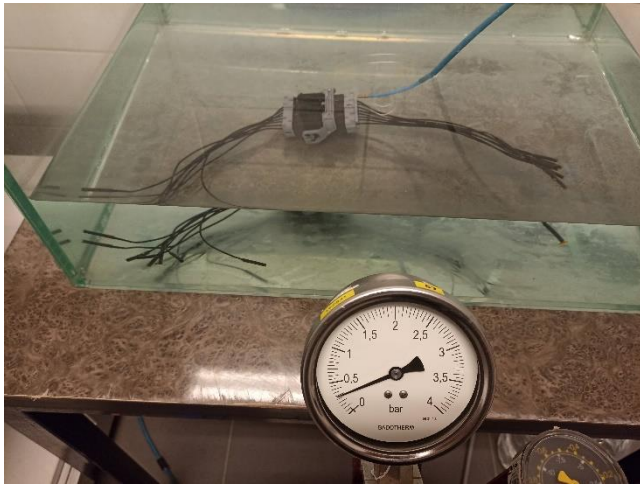
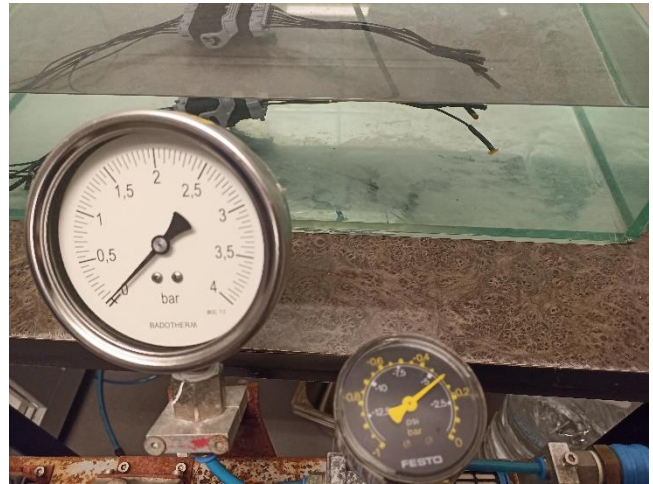
Figure 25

- 28kPa/15 sec

No bubbles visible.

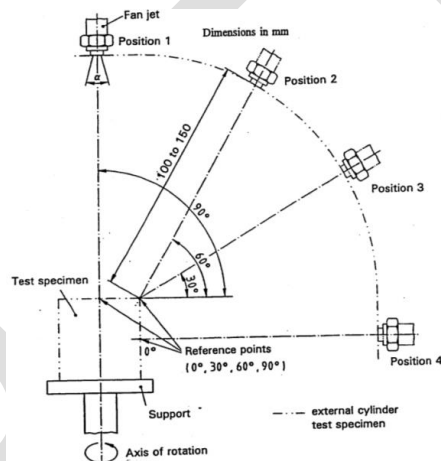
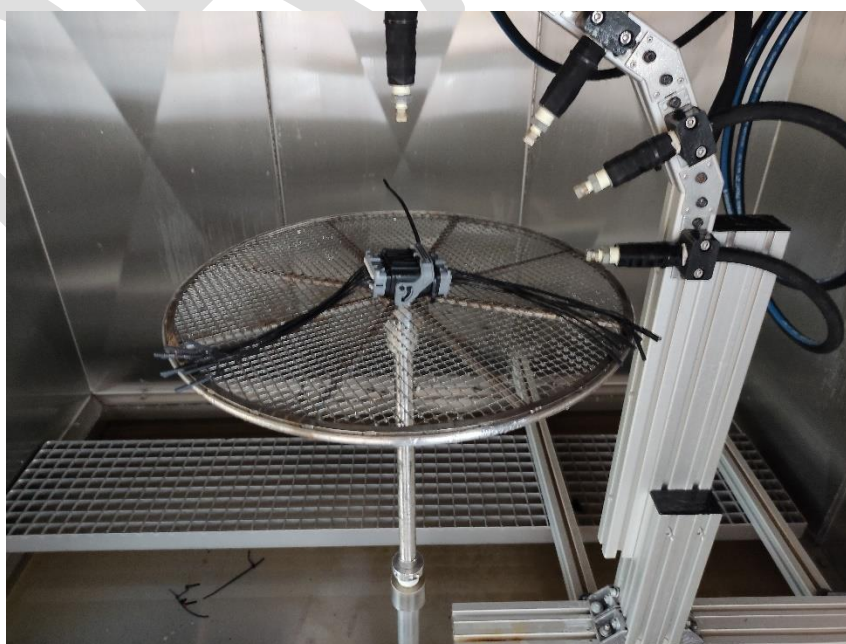
Figure 27

- Heated water 80 °C \pm 5 °C
- Rotating table

No water ingress of any sample.

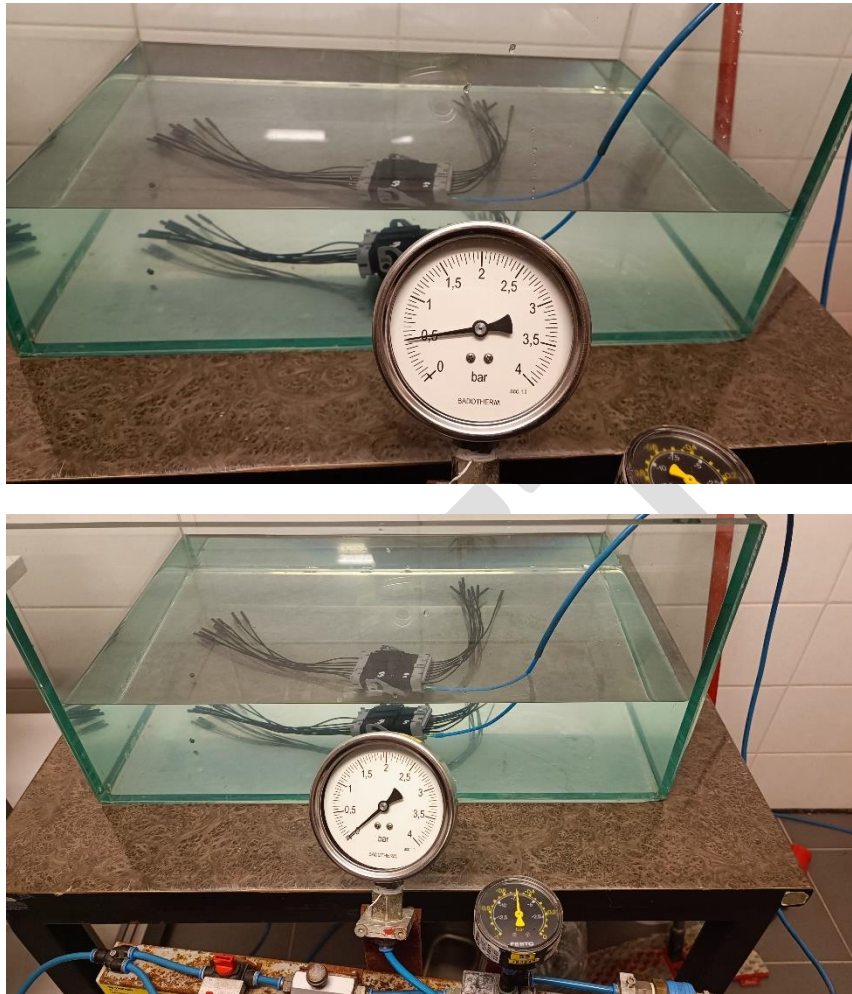
Figure 29

No bubbles visible exiting any test sample.

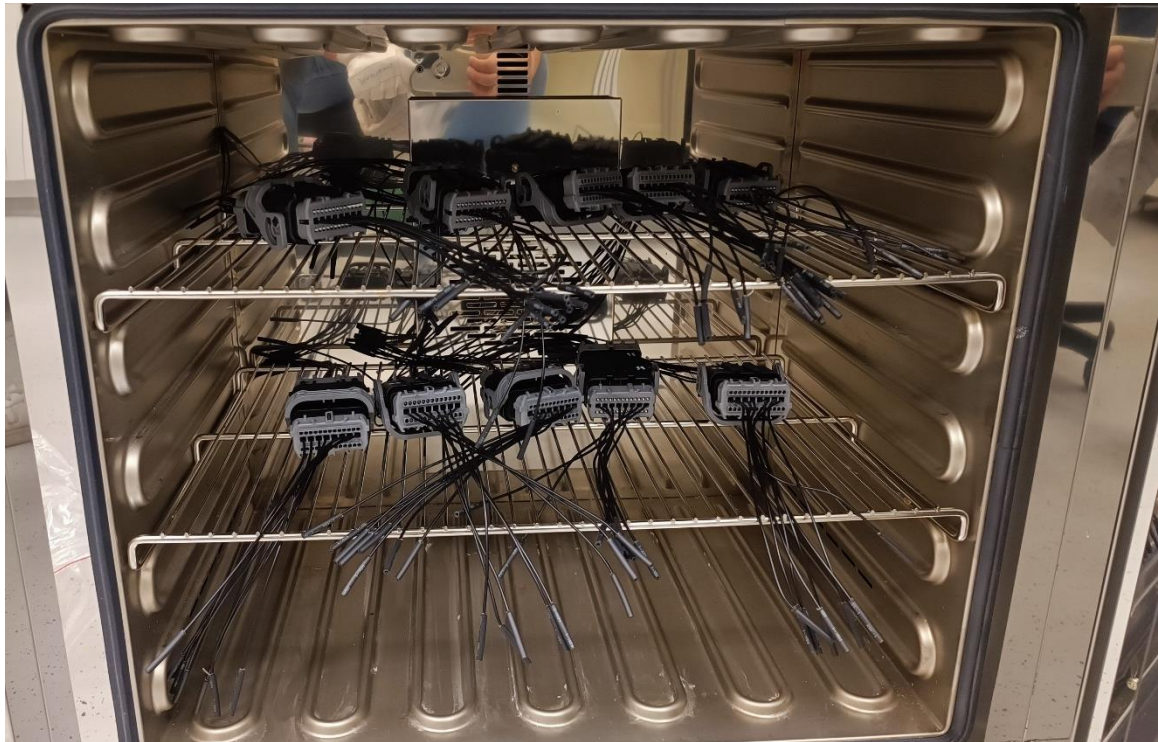
Figure 30

- Heat soak all samples for 1008 hours at the maximum temperature 125 °C
